CIPP REHAB OF WATER MAINS RUNNING THROUGH BACKYARDS

Avoiding Disruption Paramount in Wauwatosa, WI Project

By: Geoff Britnell, FER-PAL Infrastructure

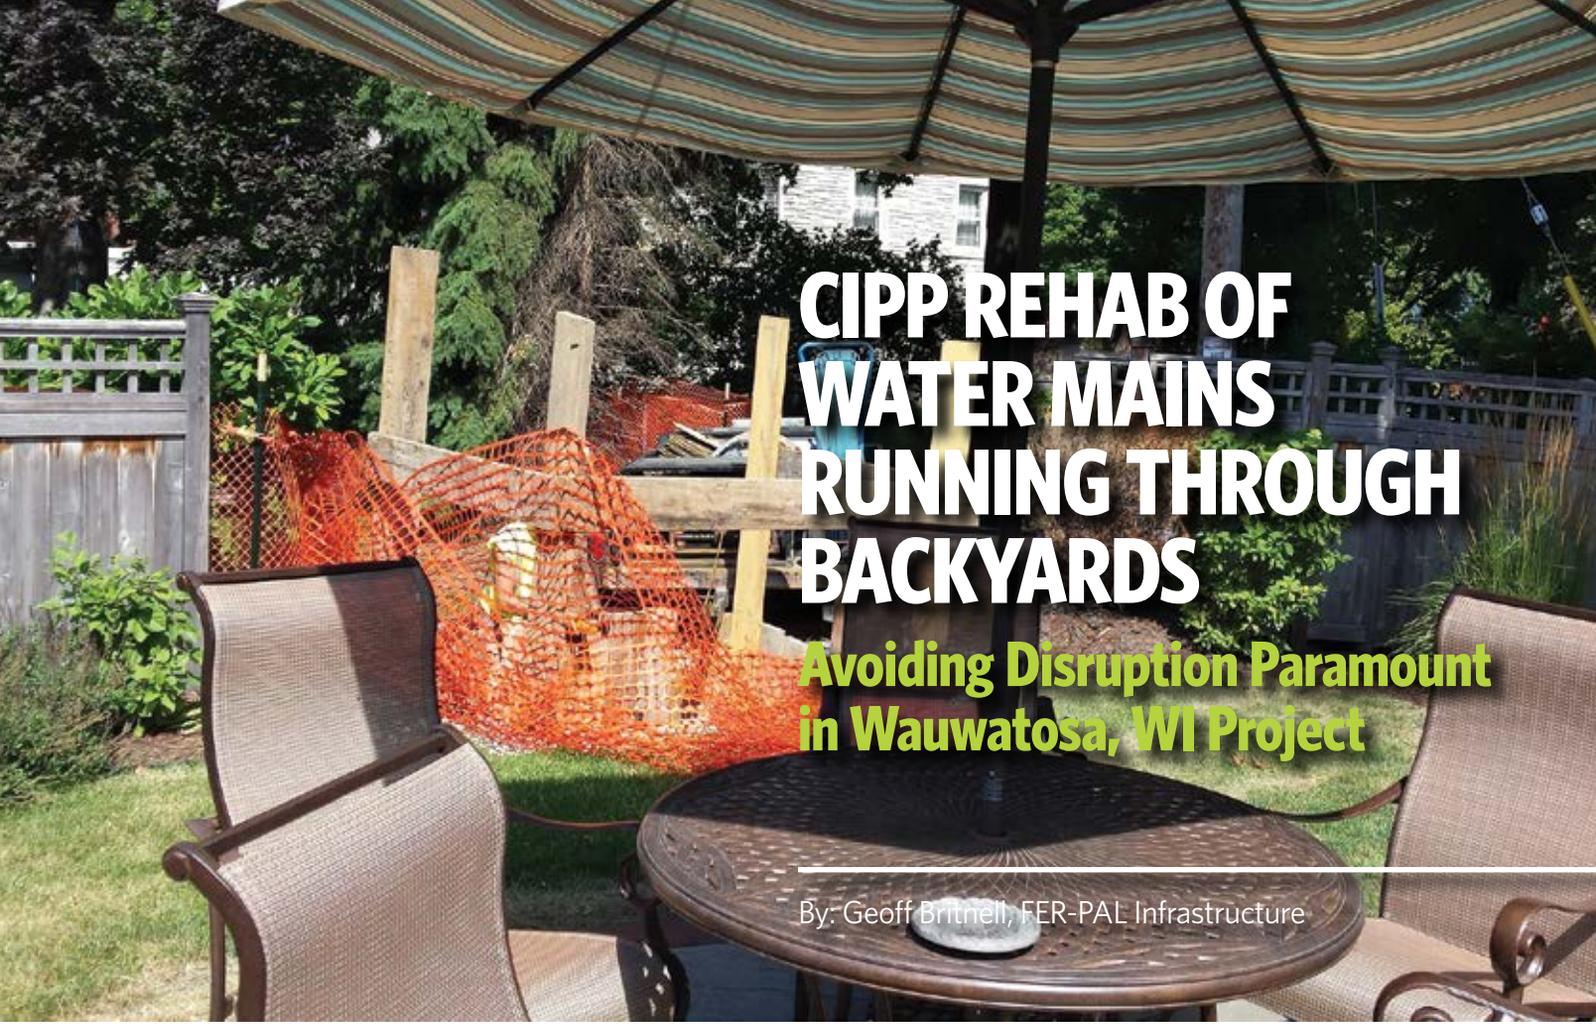
With location along the rear yard easement, excavations were designed to impact the residents as little as possible

All additional excavations were designed for locations that impacted the residents as little as possible. The pits themselves were designed to be 6ft by 9ft and had specialty shoring designed and built by FER-PAL inserted into the pit to allow a safe working environment.

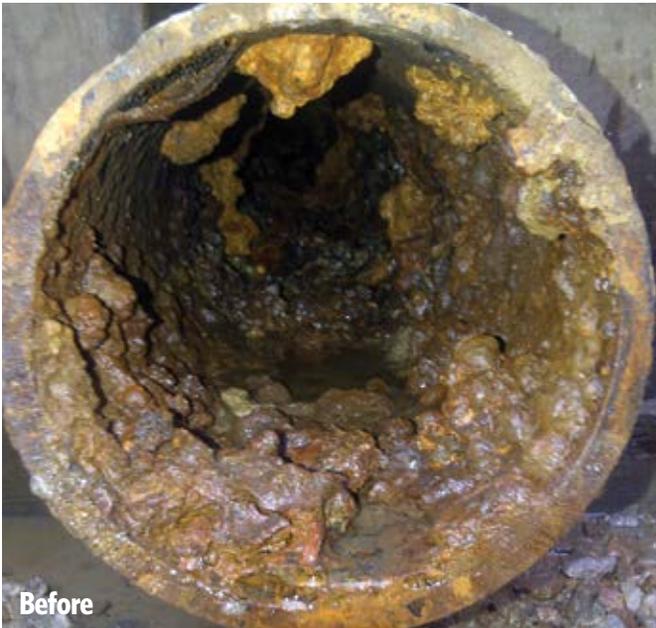
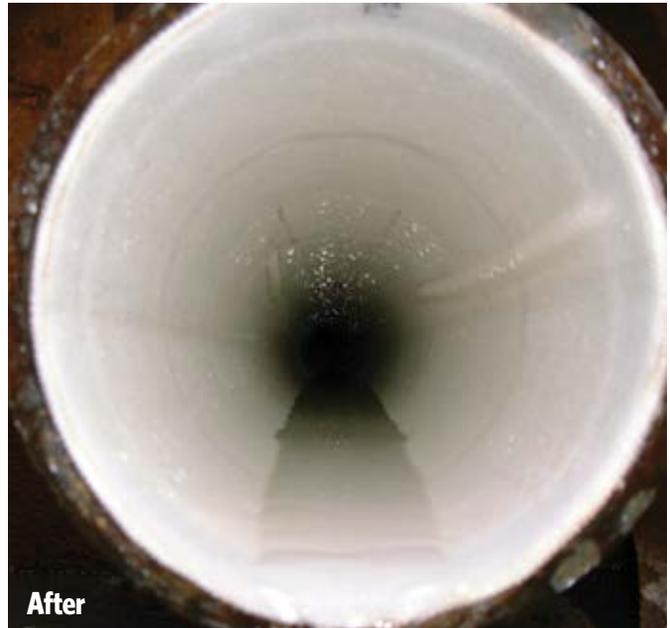
Epoxy migrates through the outer jacket of the liner to fill all voids around the services and any existing spaces within the host pipe, creating a full bond to the interior of the old water main

Once the interior of the main was prepared, the CIPP liner was pulled into place through rollers on the installation truck and rollers attached to the main. Epoxy resin was injected in between the two layers of the liner as it was pulled through a refrigerated truck and into place inside of the main. Once in place, the liner was capped off on each end, pressurized, and cured with hot water for a period of 1.5 hours. During the curing process epoxy migrates through the outer jacket of the liner to fill all voids around the services as well as any existing spaces within the host pipe. In doing so, it creates a full bond to the interior of the old water main.
